# Owyhee Dairy Complaint Investigation Report

By Emily Montague

May 22, 2019

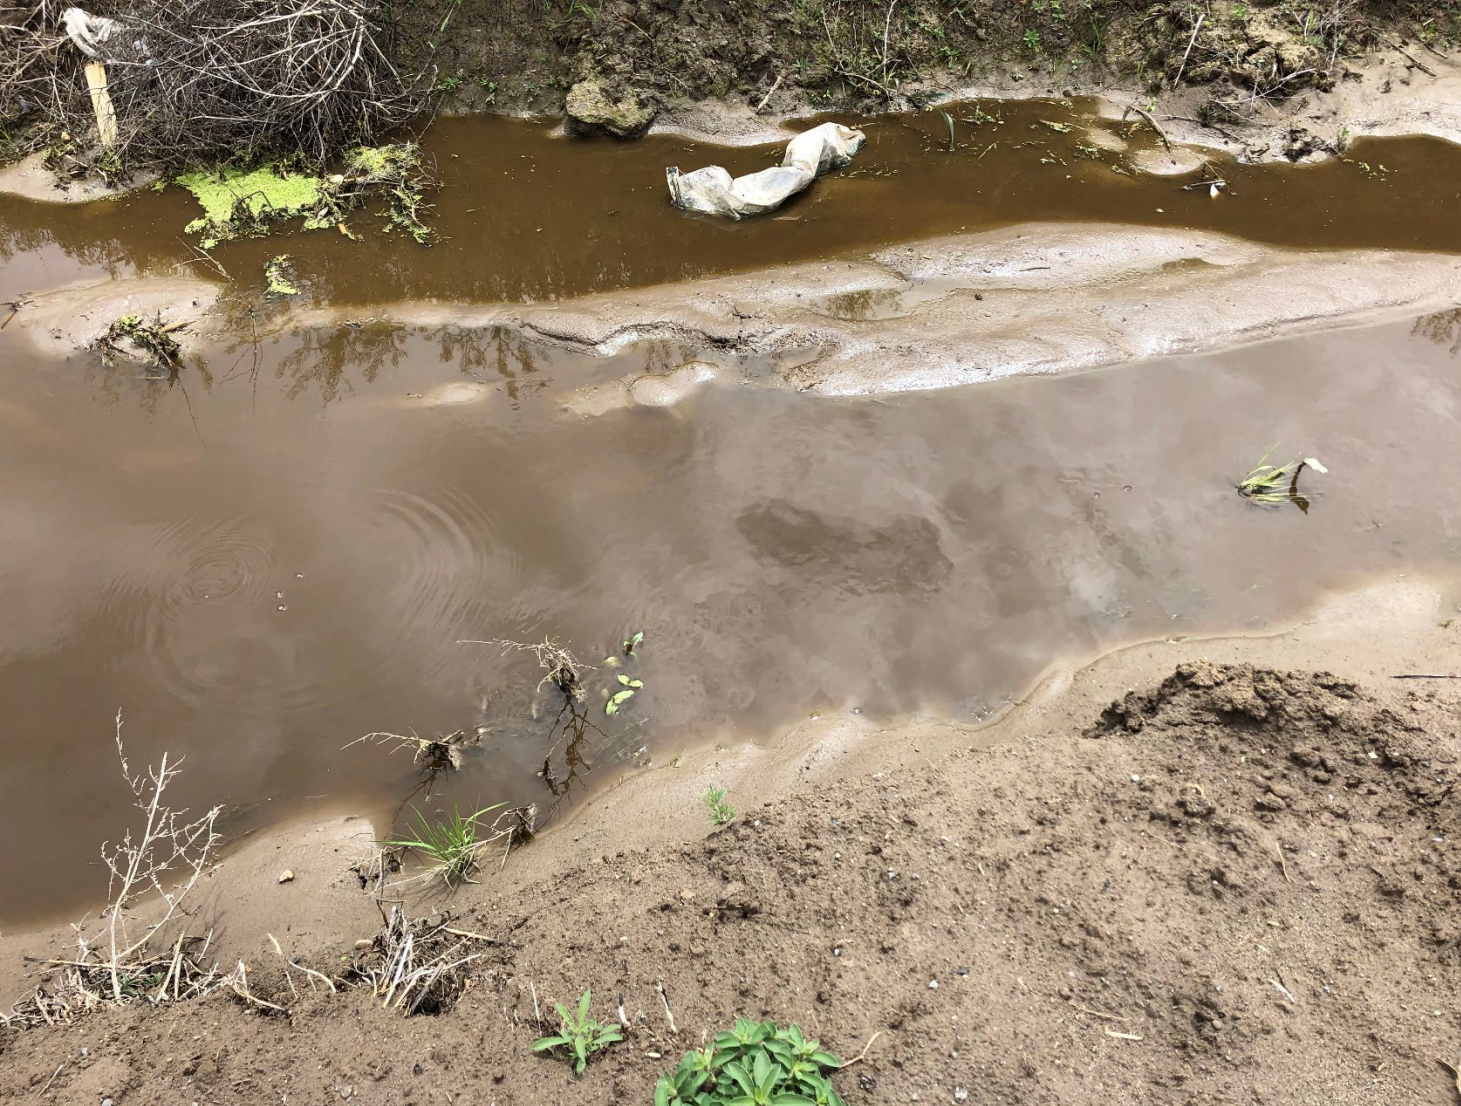
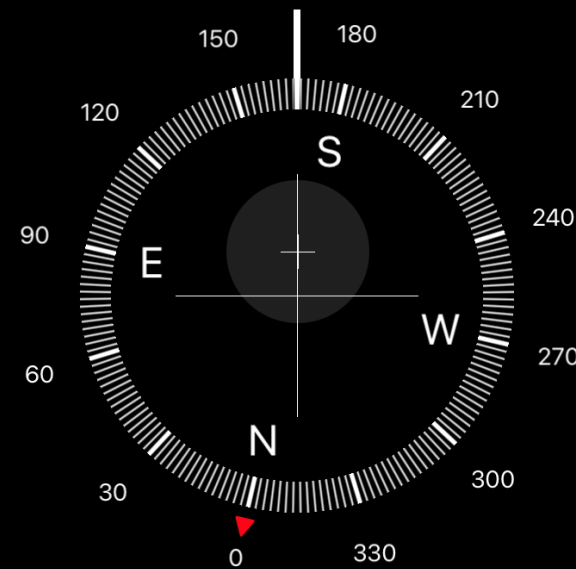
Photograph taken by Inspector Emily Montague on May 21, 2019 facing 166 degrees South shows ditch water downstream from point of discharge at the Archabal Drain/Town Ditch. Ditch contents were thoroughly contaminated with effluent from Owyhee Dairy discharge on May 221, 2019. At the time of inspection, Inspector Montague observed a strong odor coming from ditch contents consistent with the effluent observed at Owyhee Dairy on May 21, 2019. Samples for evidence were taken at this time.

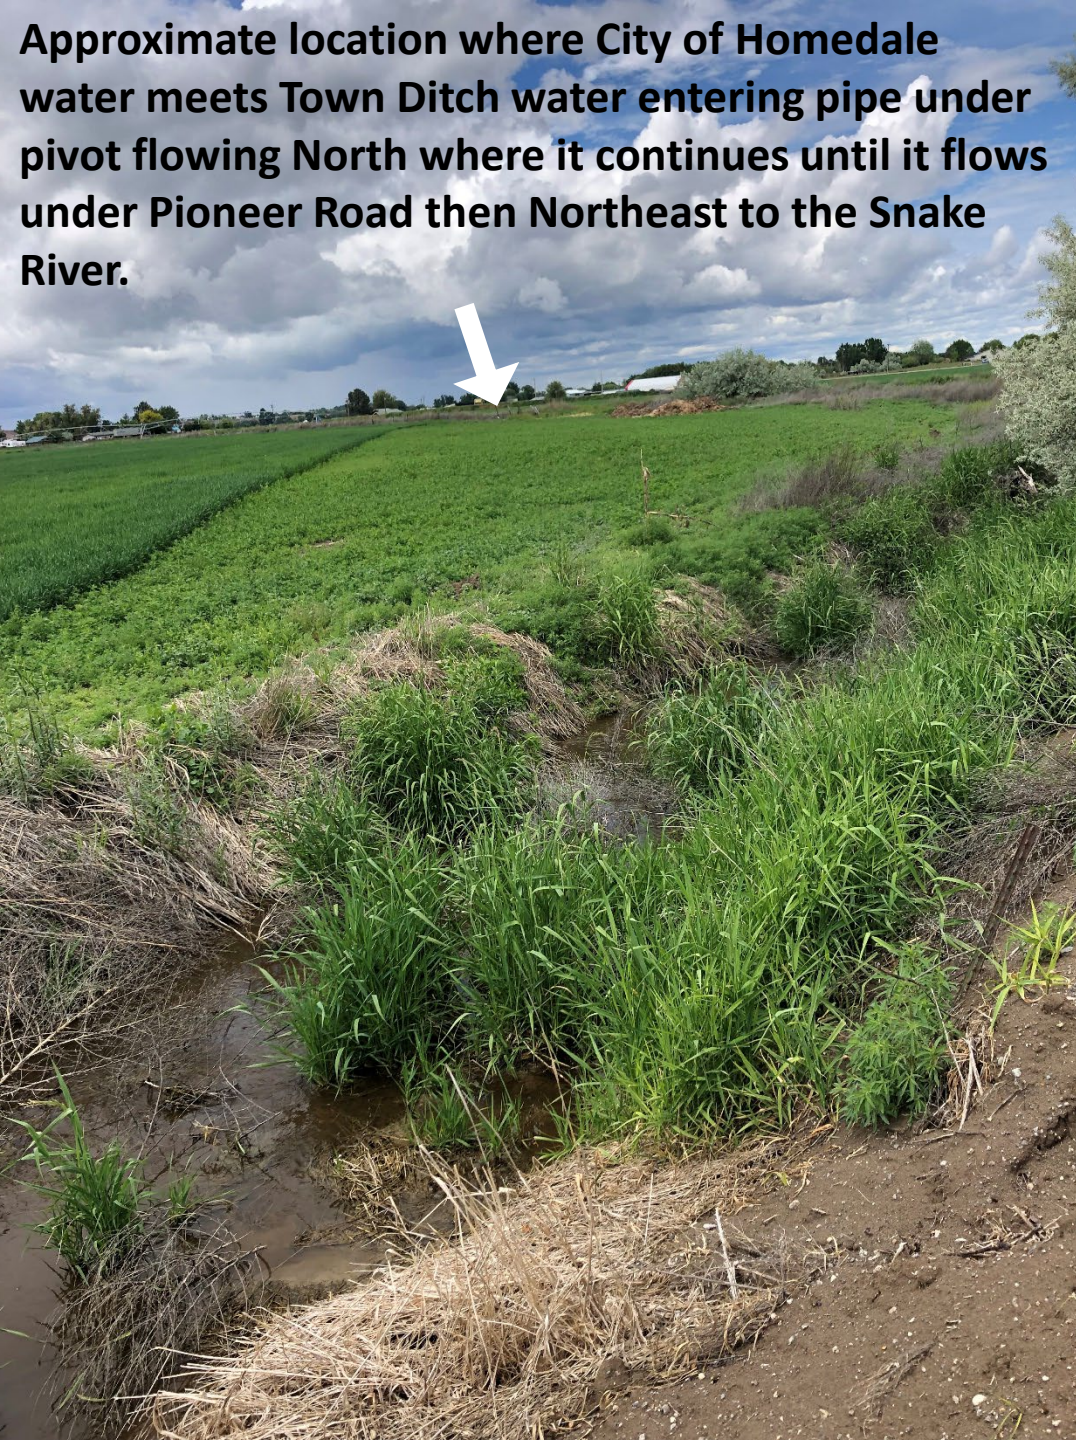
**Approximate location where City of Homedale water meets Town Ditch water entering pipe under pivot flowing North where it continues until it flows under Pioneer Road then Northeast to the Snake River.**

Photograph taken by Inspector Montague on May 21, 2019 facing Northwest shows Town Ditch contents heading North then Northeast where contents reach the Snake River approximately 2,387 yards downstream.

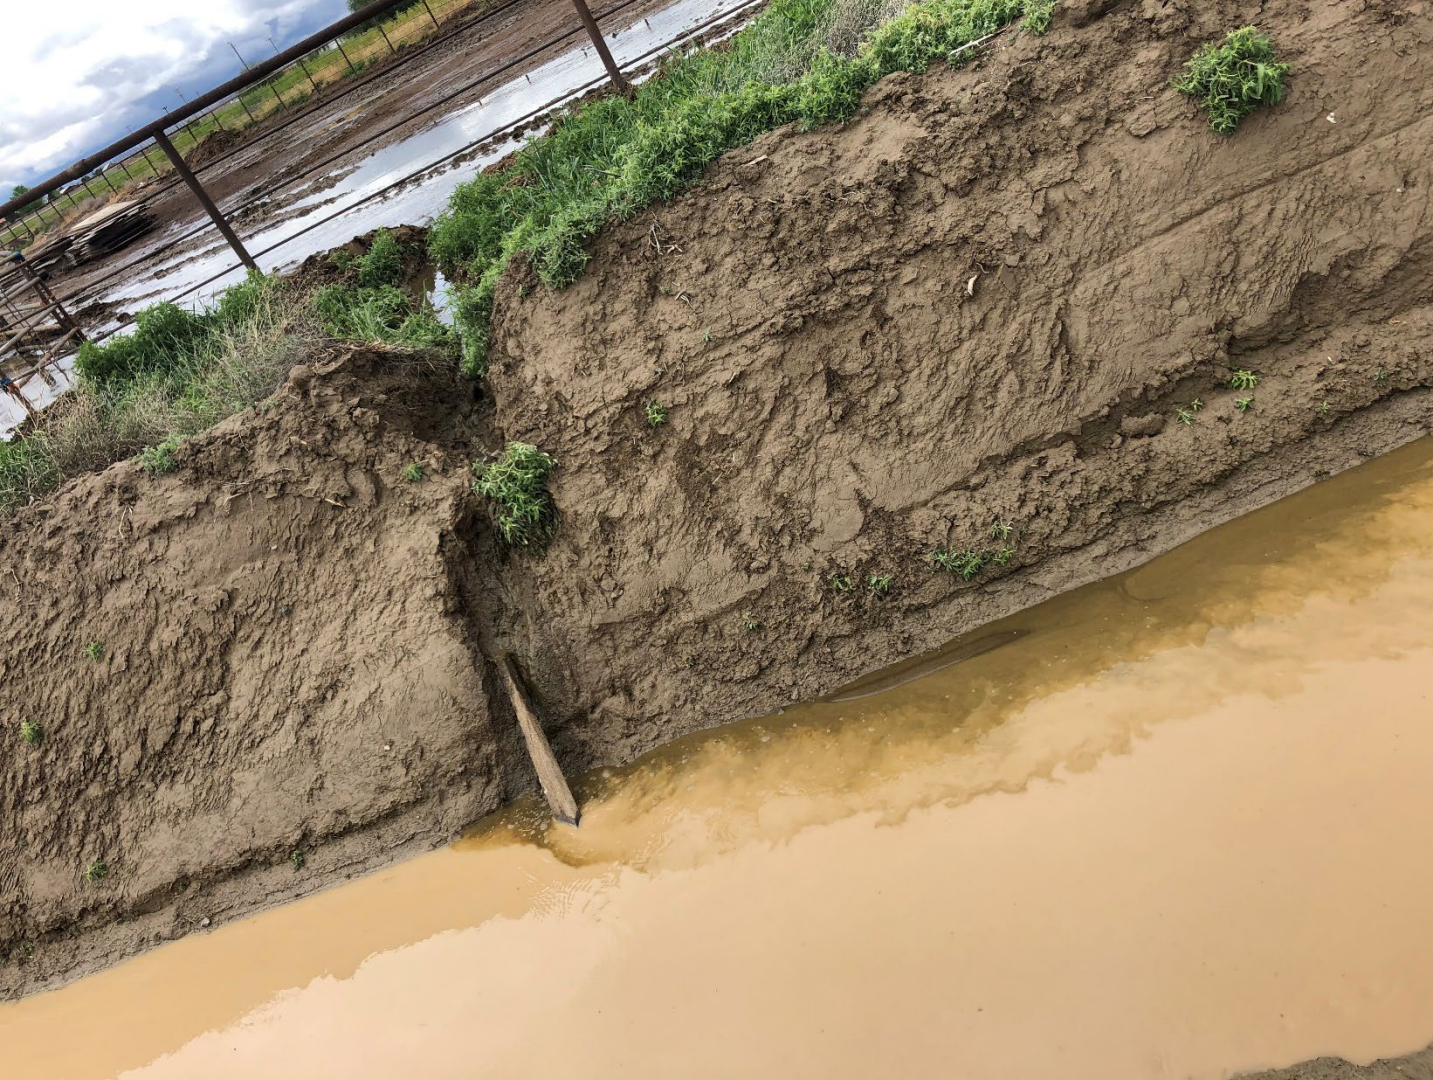
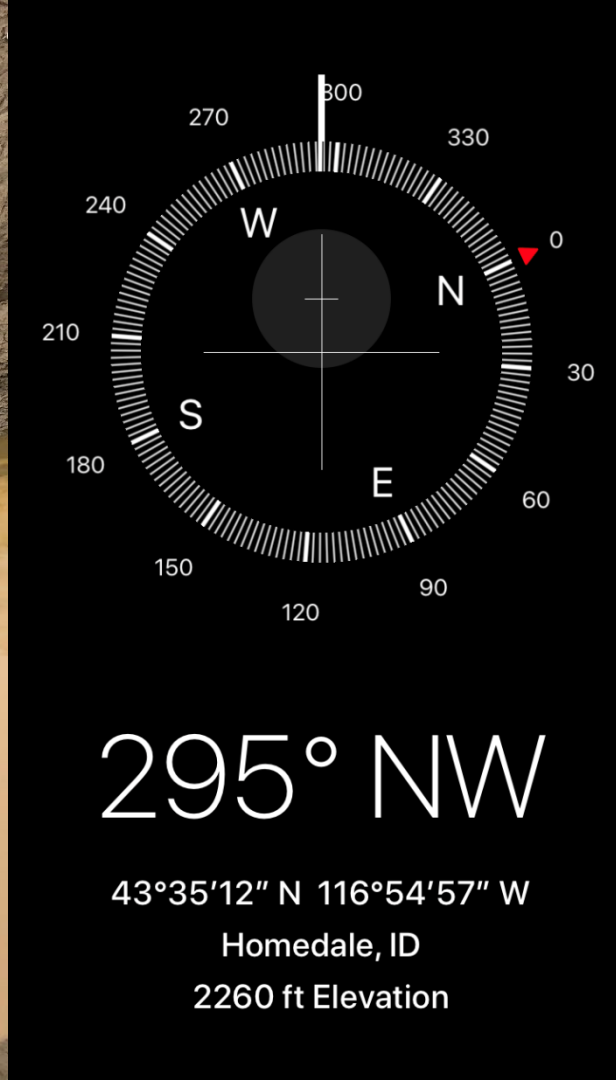
Photograph taken by Inspector Montague on May 21, 2019 facing 295 degrees Northwest shows main point of Owyhee Dairy discharge from Southeast corrals into Town Ditch. Samples were taken for evidence shortly after discharge was observed.

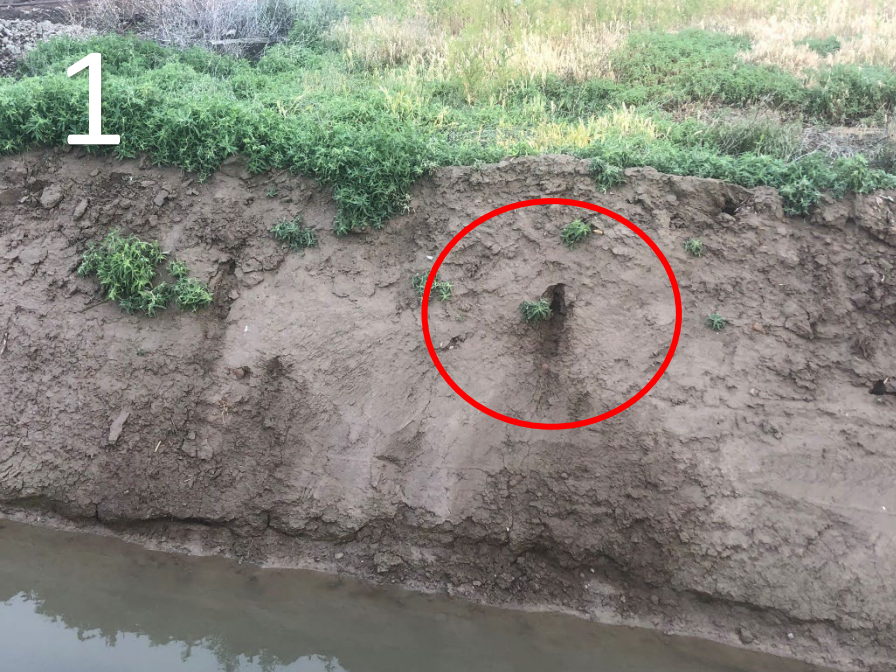
1

Gravel put in place by Mr. Williams on the evening of May 21, 2019 to try and prevent additional runoff from going out of the corrals and into Town Ditch

All three photographs taken along southeast corral bank between the corrals and the bank of the ditch show six places where effluent was running off into Town Ditch on March 21, 2019. Photographs taken by Inspector Montague show runoff is no longer flowing into Town Ditch at the time of inspection conducted on March 22, 2019.

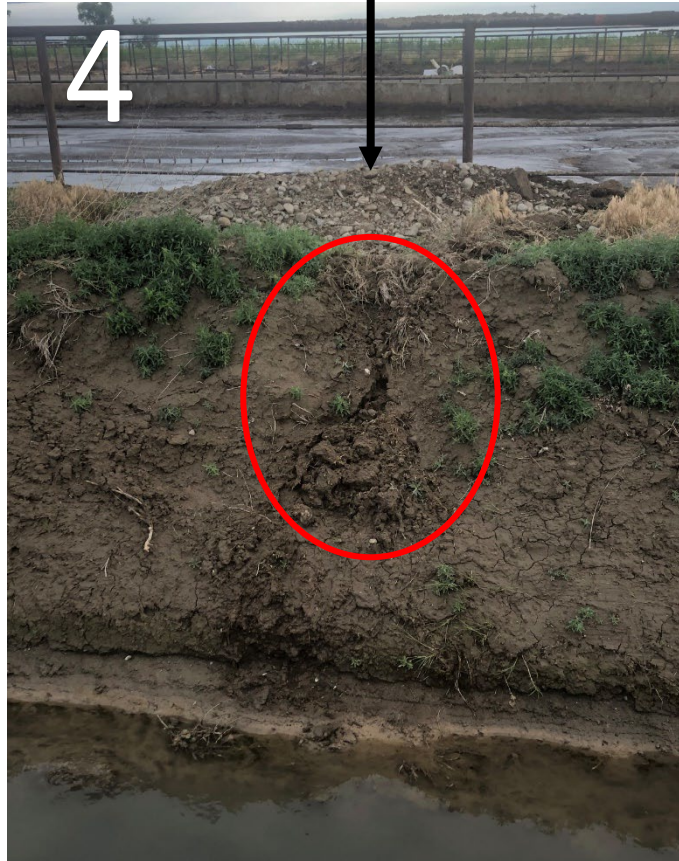
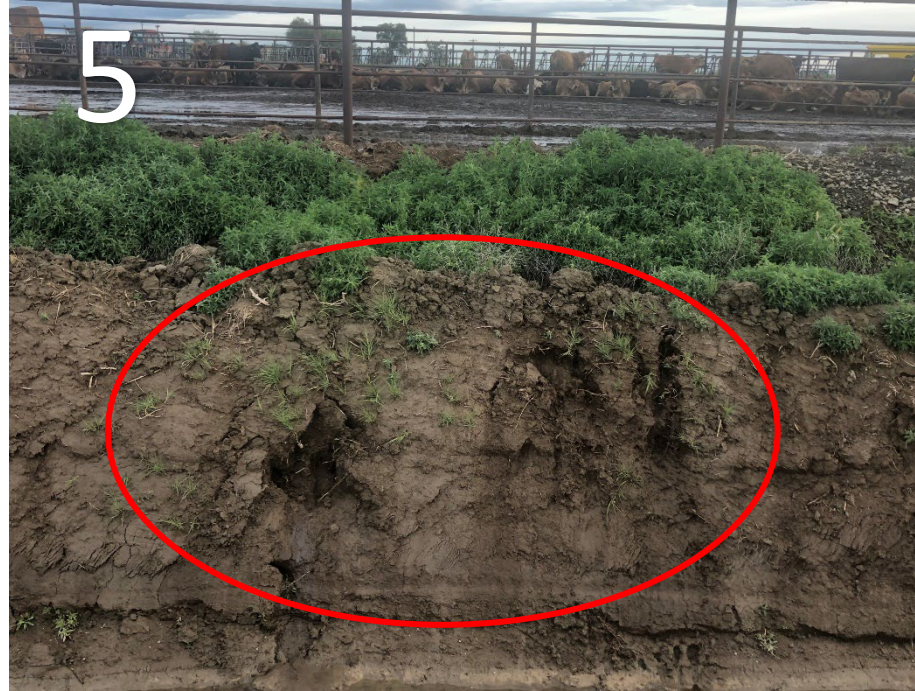
Photograph taken by Inspector Montague taken on May 22, 2019 shows runoff is no longer flowing into Town Ditch from the main point of where runoff was discharging into Town Ditch the previous day.

Gravel put in place by Mr. Williams on the evening of May 21, 2019 to try and prevent additional runoff from going out of the corrals and into Town Ditch

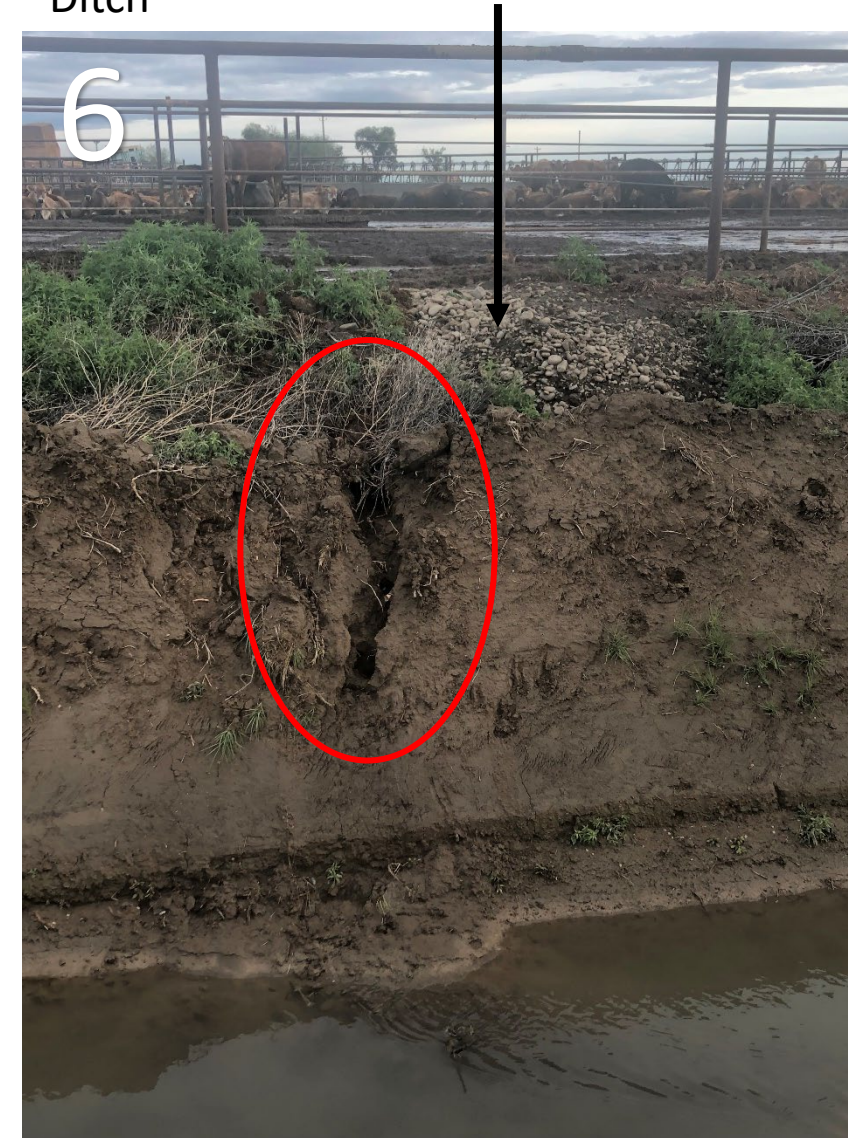
Gravel put in place by Mr. Williams on the evening of May 21, 2019 to try and prevent additional runoff from going out of the corrals and into Town Ditch

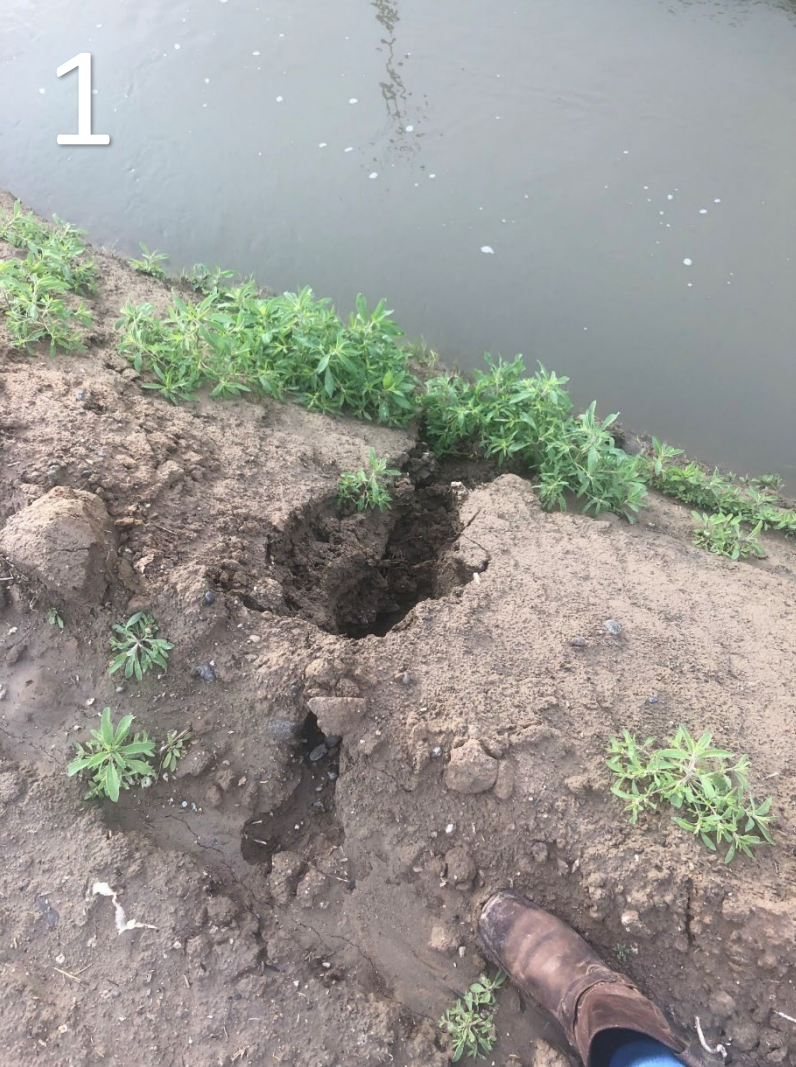
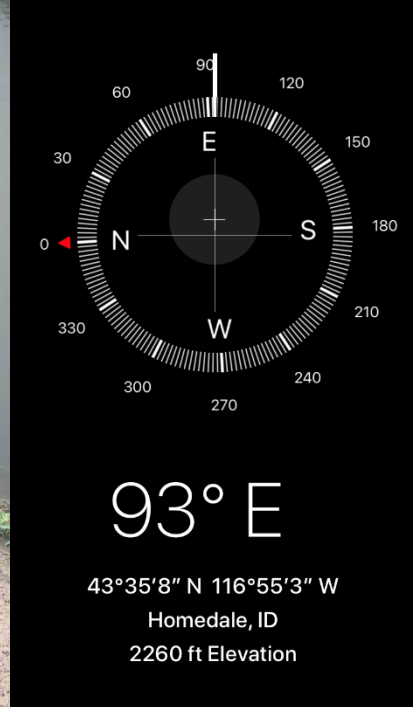
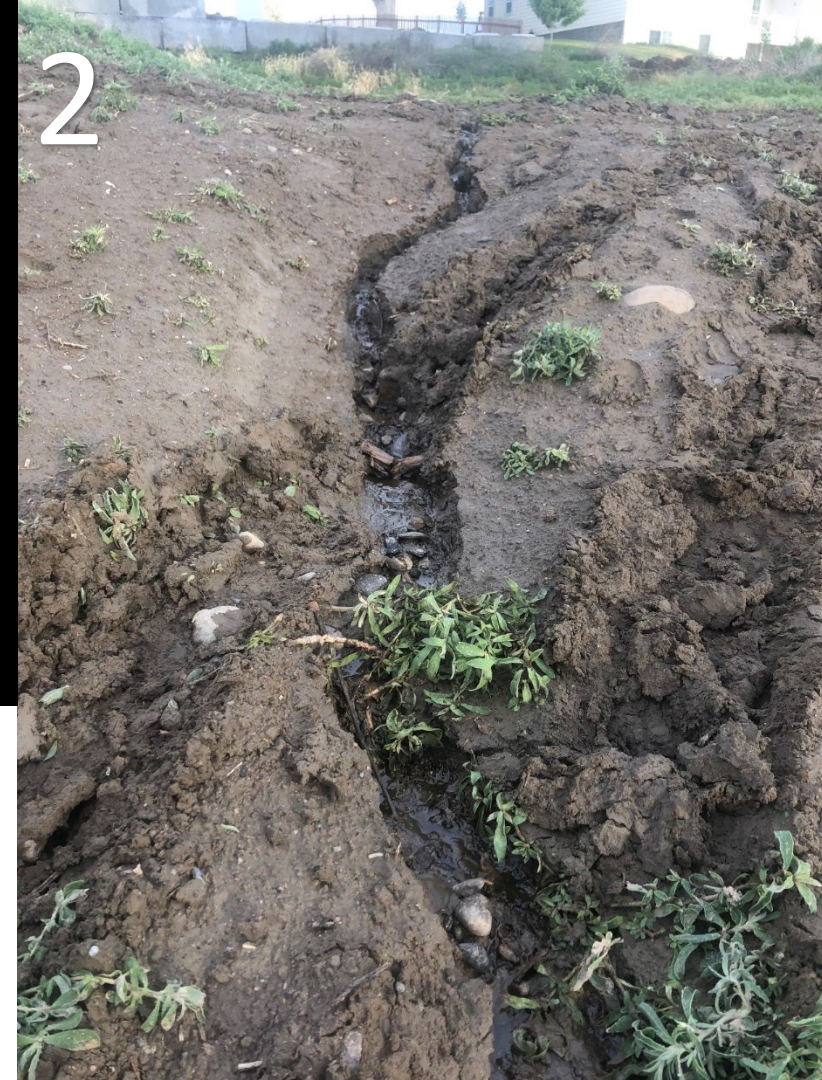
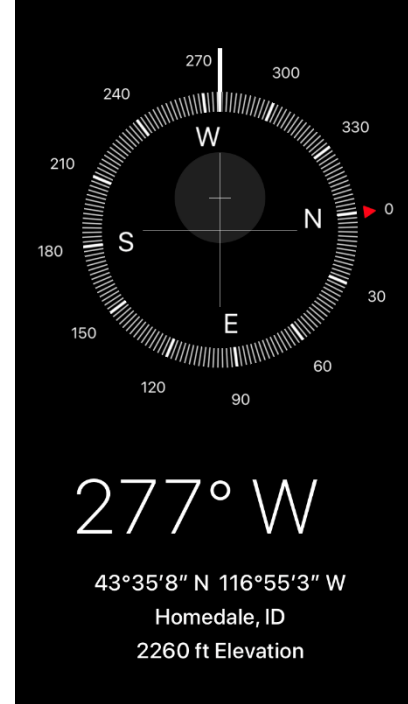
Photograph 1 taken by Inspector Montague on May 22, 2019 shows the point where commodity storage runoff was flowing into Town Ditch on May 21, 2019. Photograph shows runoff was no longer flowing into Town Ditch at the time of inspection on May 22, 2019. Photograph 2 taken by Inspector Montague on May 22, 2019 shows channel created by runoff from commodity storage area where runoff was flowing Southeast towards Town Ditch on May 21, 2019. Photograph shows runoff was no longer flowing into Town Ditch at the time of inspection on May 22, 2019. There was still a sheen film and smell of oil mixed with diesel on May 22, 2019.

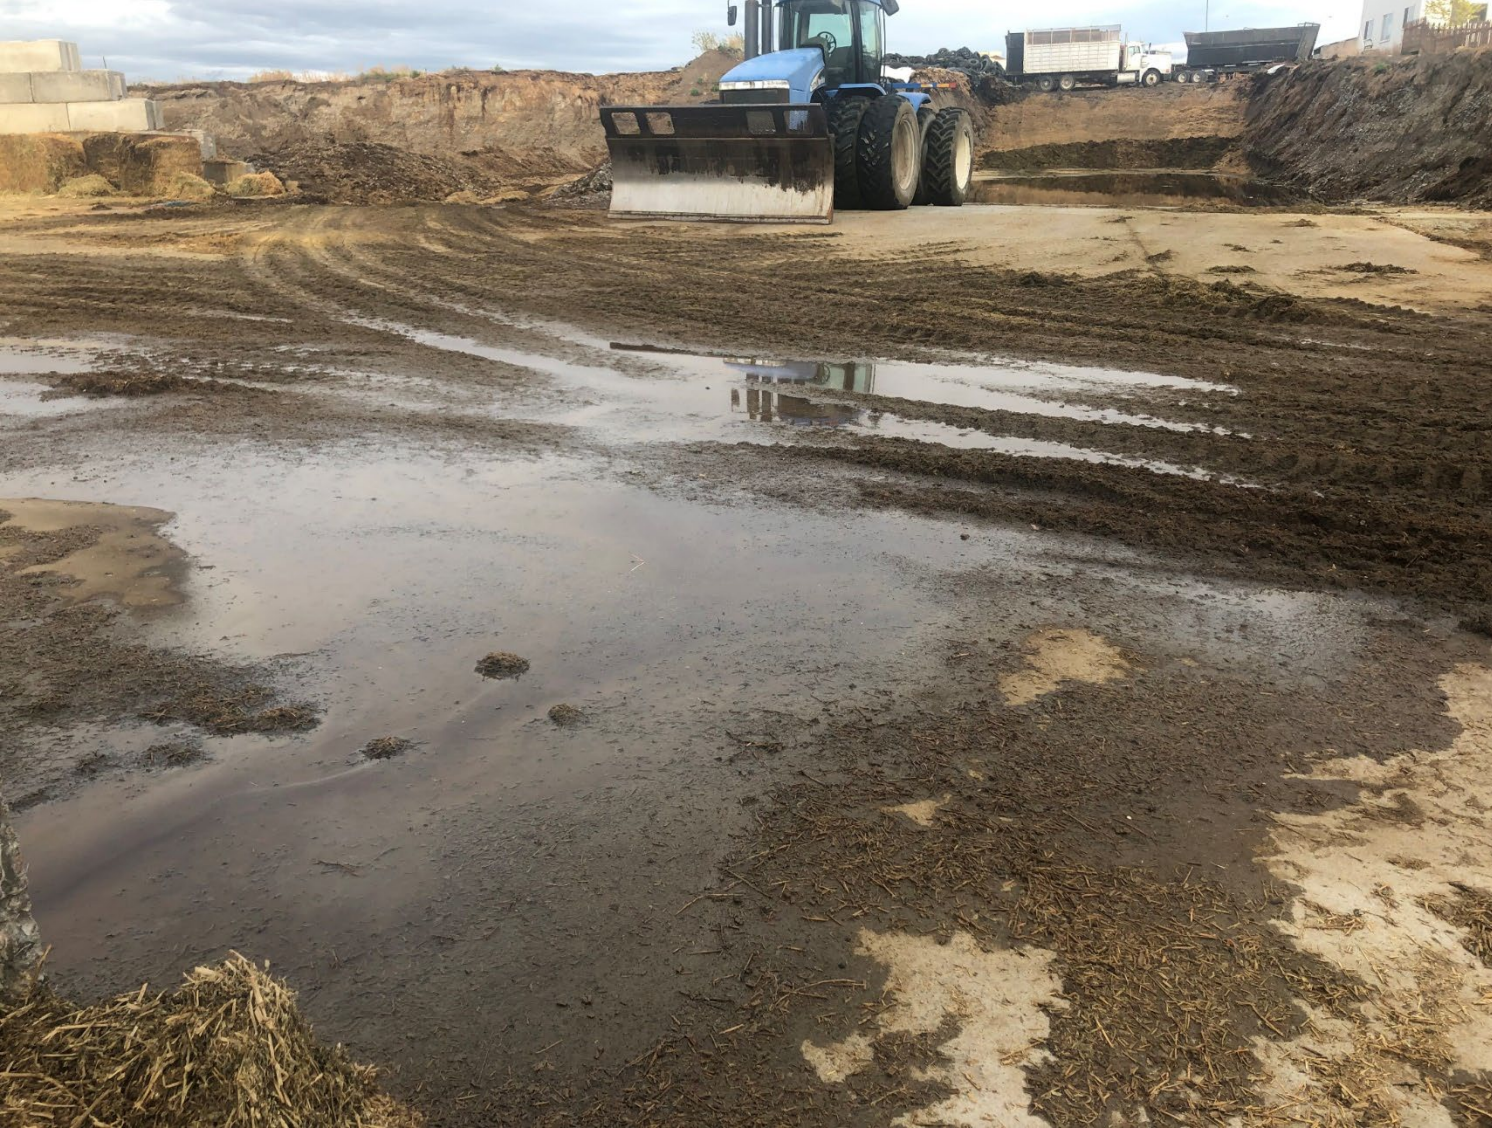
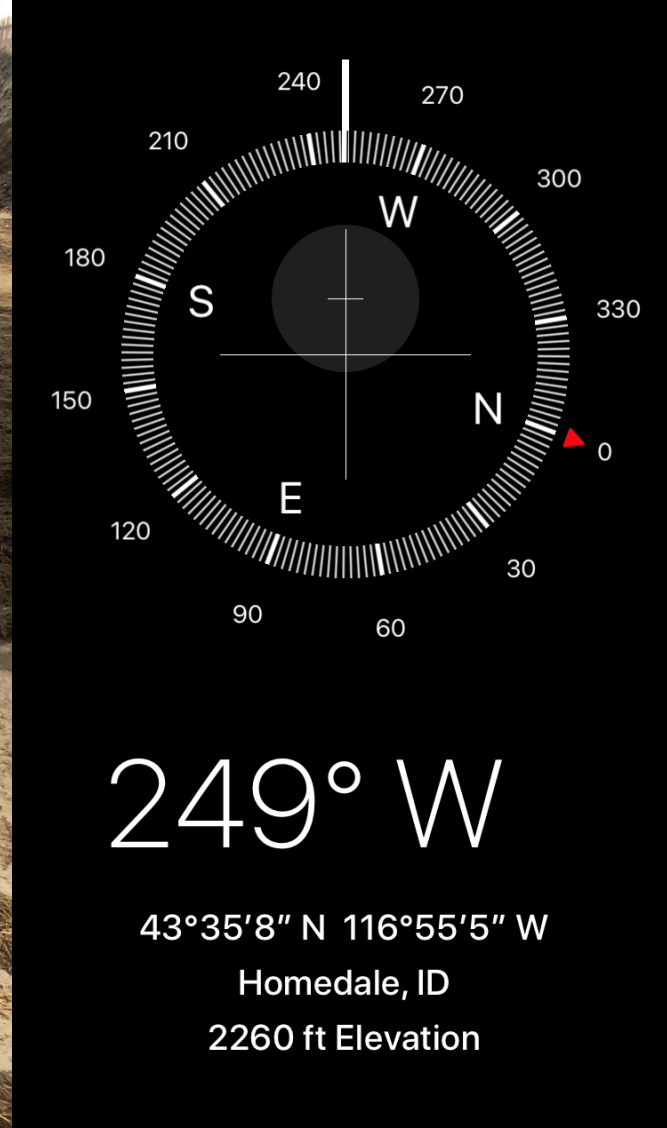
Photograph taken by Inspector Montague on May 22, 2019 taken facing 249 degrees West shows placement of commodity storage area where pooled nutrients and oil and diesel fuel mix next to large cinder blocks that enclose commodity storage area.

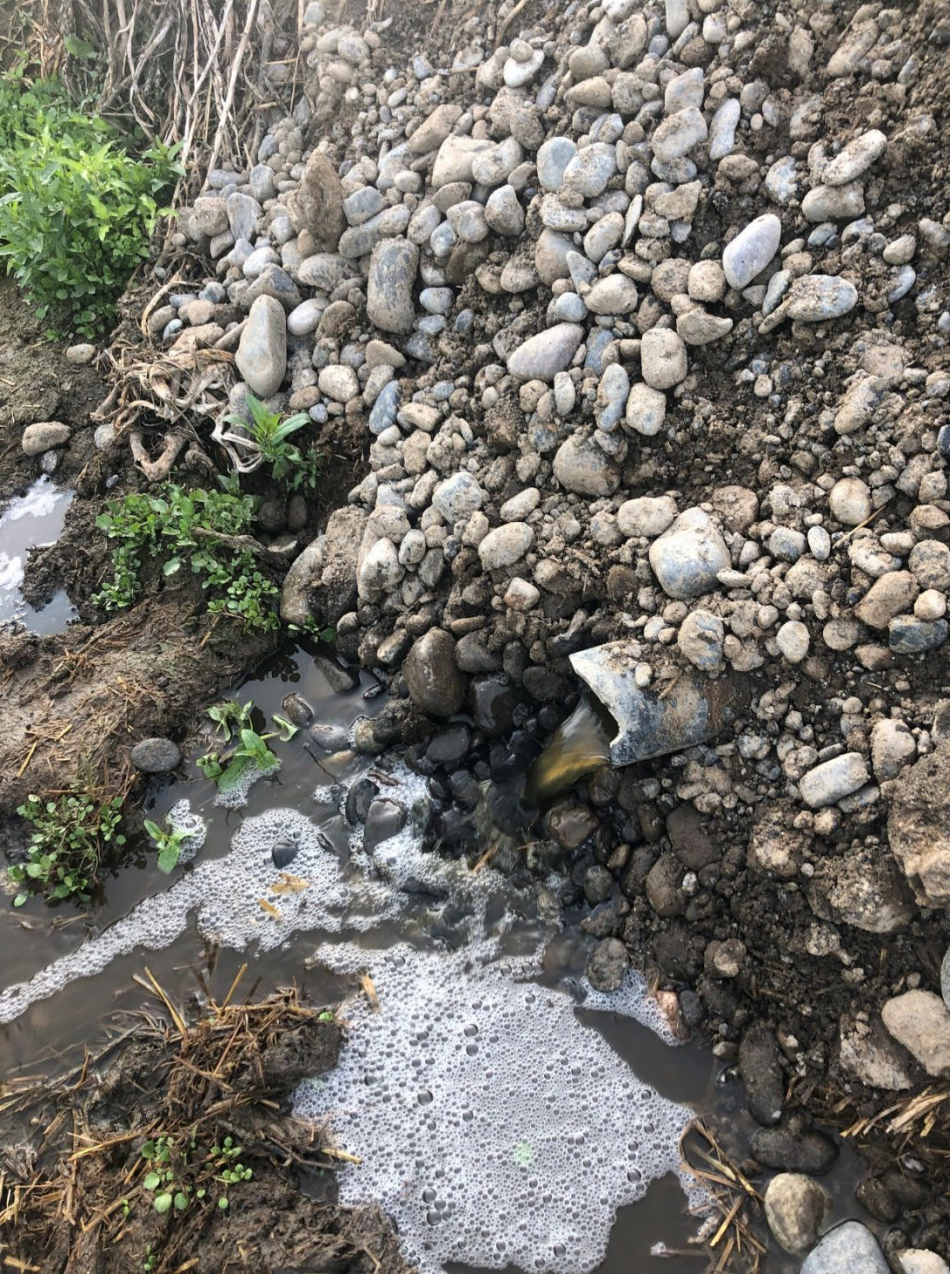
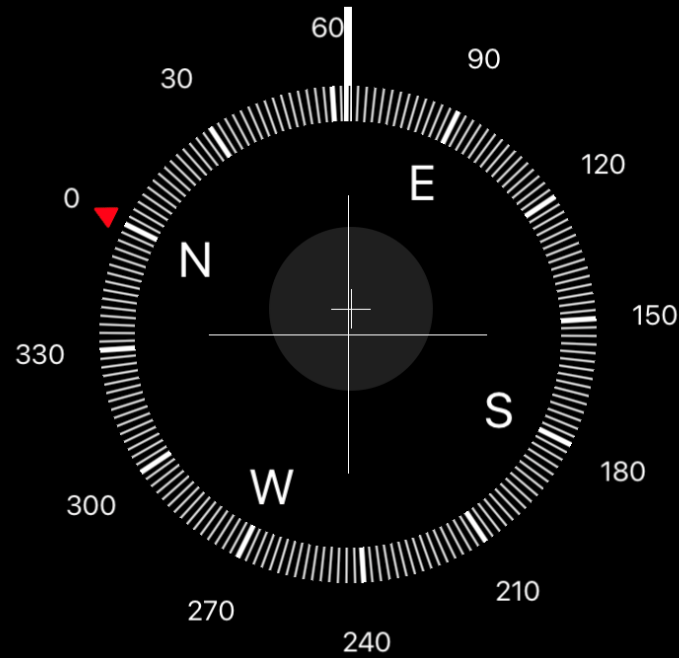
Photograph taken by Inspector Montague on May 22, 2019 facing 63 degrees Northeast shows pipe head coming from north corral area into ditch that no longer has a cap containing effluent from discharging into the ditch. Samples were taken at this time to show contents of liquids discharging from pipe head.

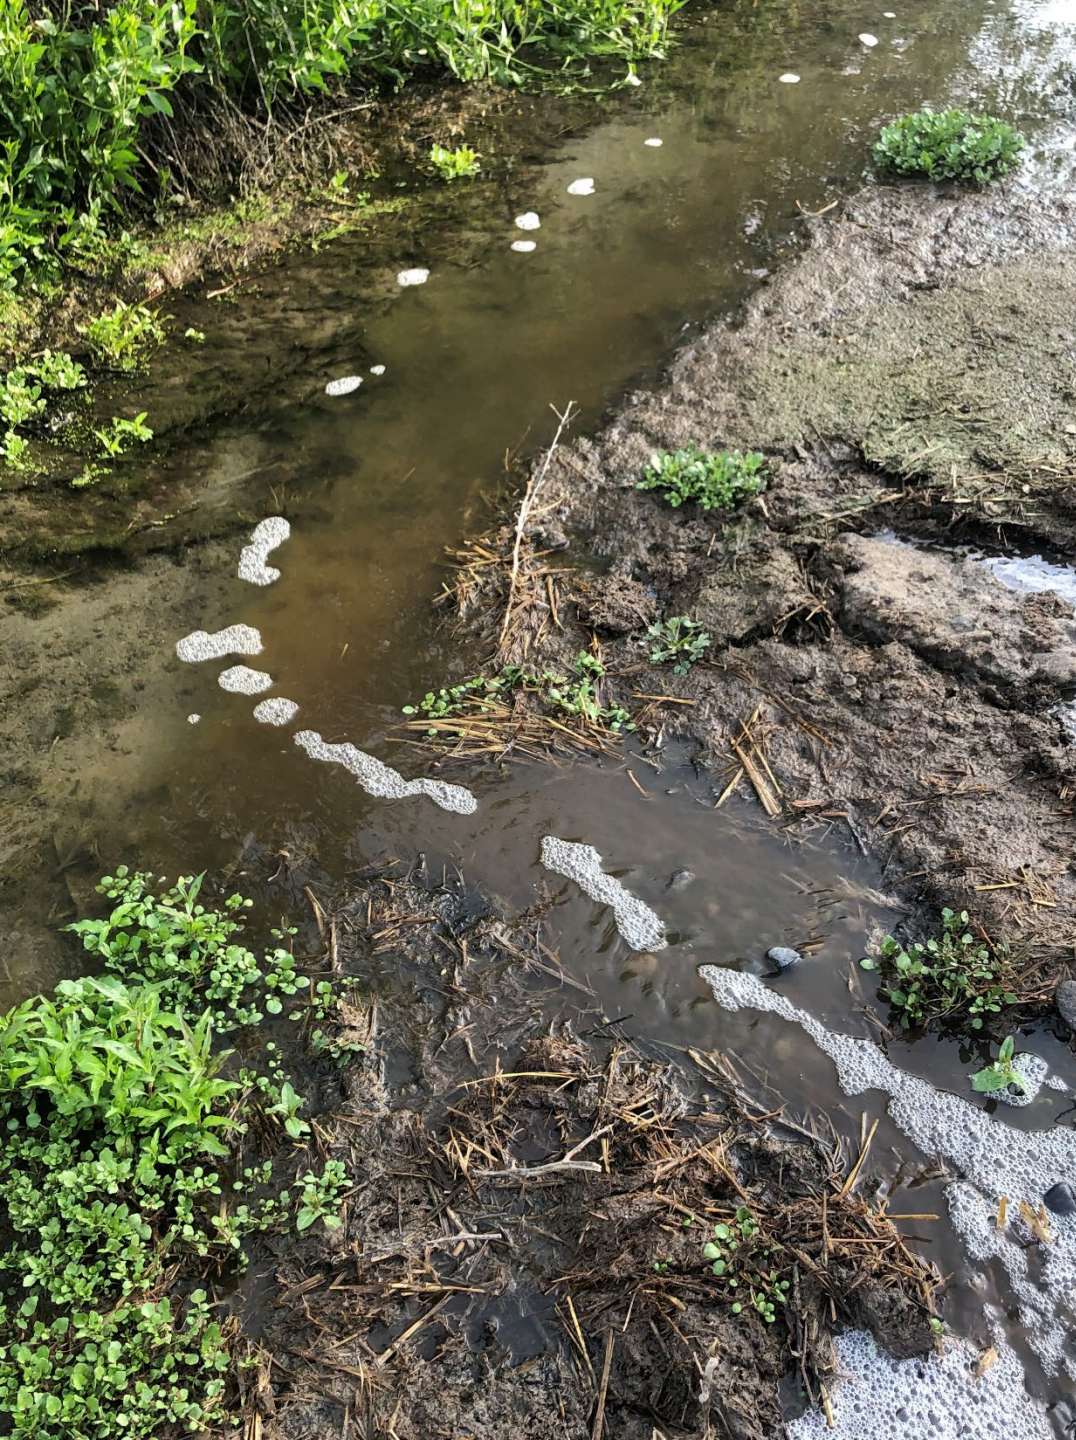
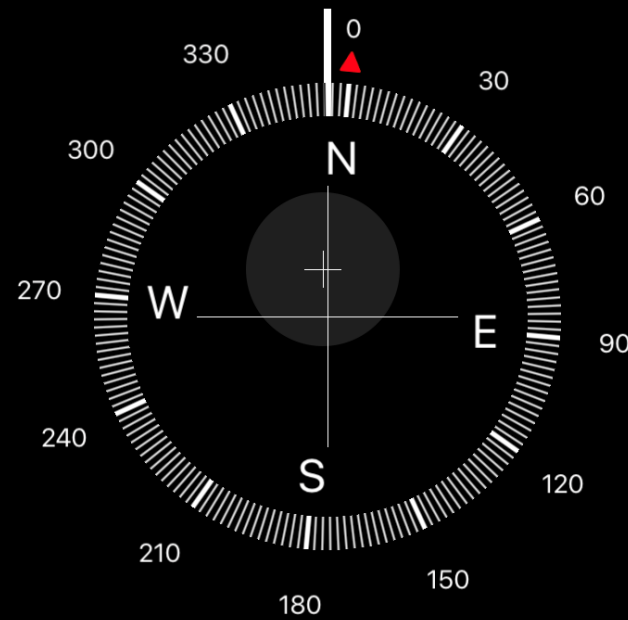
Photograph taken by Inspector Montague on May 22, 2019 facing 354 degrees North shows contents from pipe head that no longer has a cap discharging into the ditch. Samples were taken at this time to show contents of liquids discharging from pipe head.

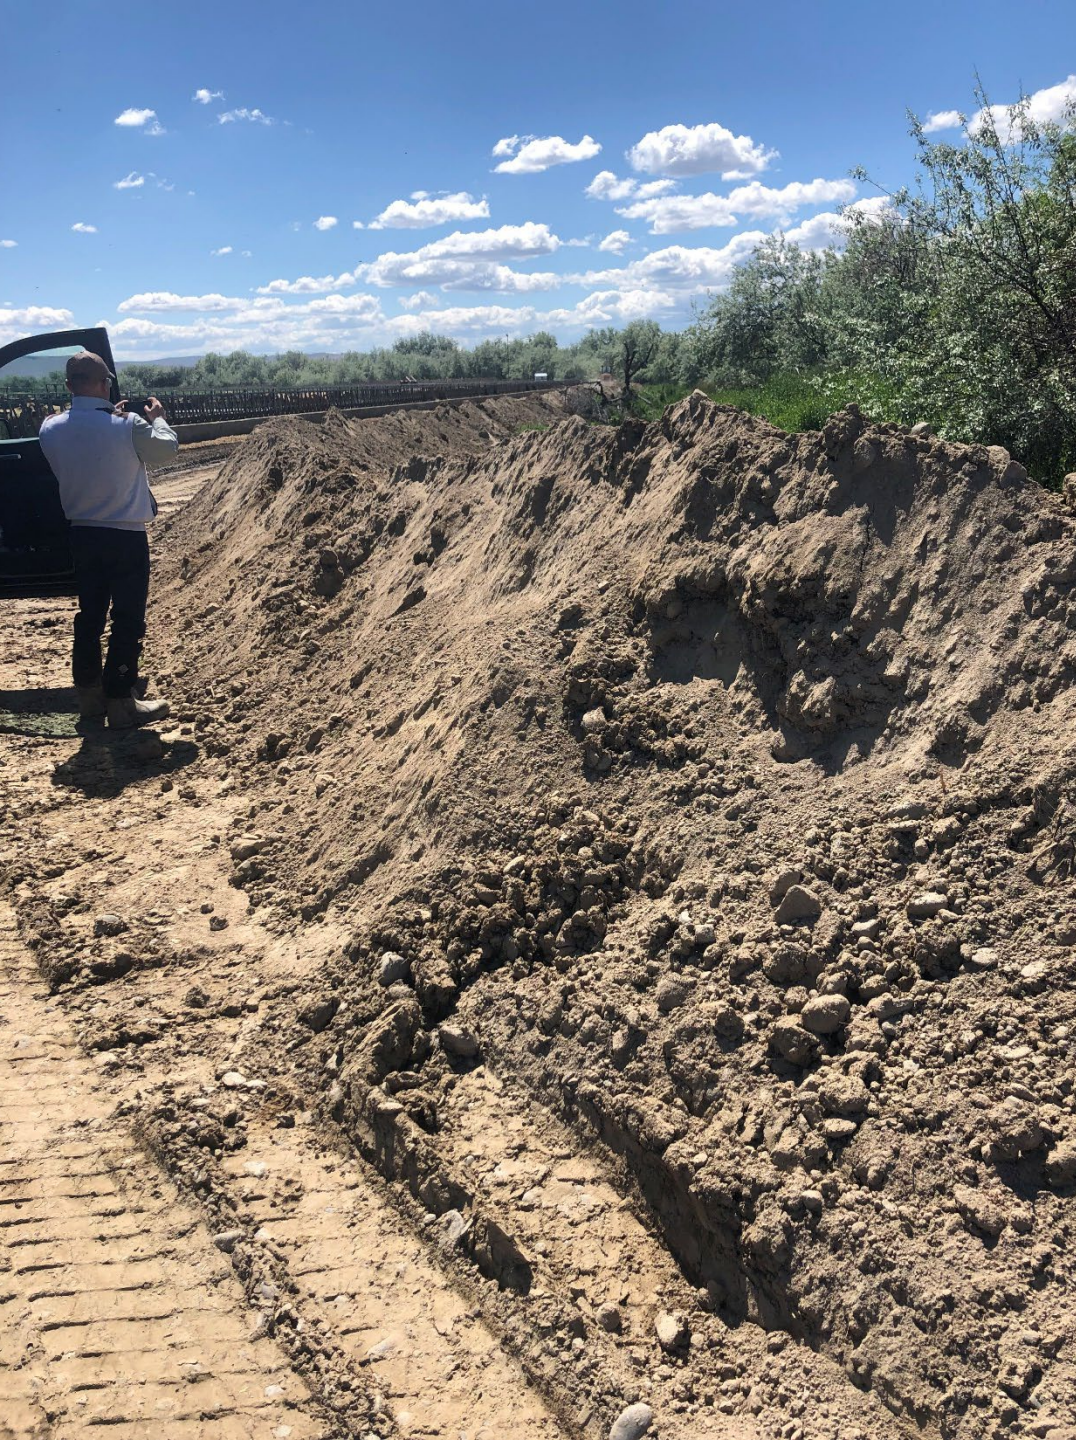
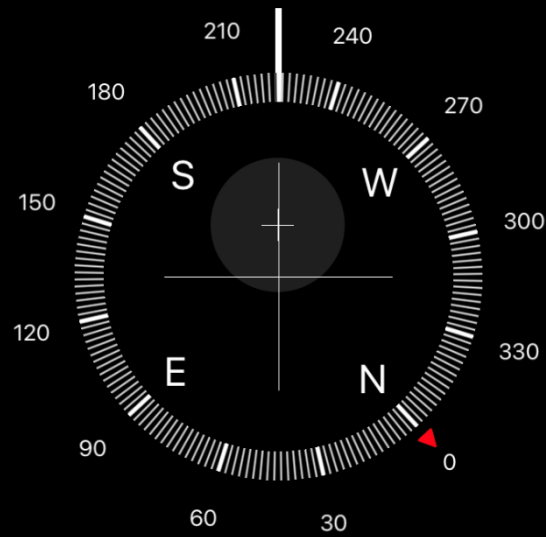
Photograph taken by Inspector Montague on May 23, 2019 facing 222 degrees Southwest shows four feet high berming added between the North corrals and the ditch that borders the North and Northwest side of Owyhee Dairy. Berming still needs to be compacted to the required 300 PSI to protect potential runoff from the facility from entering the ditch.

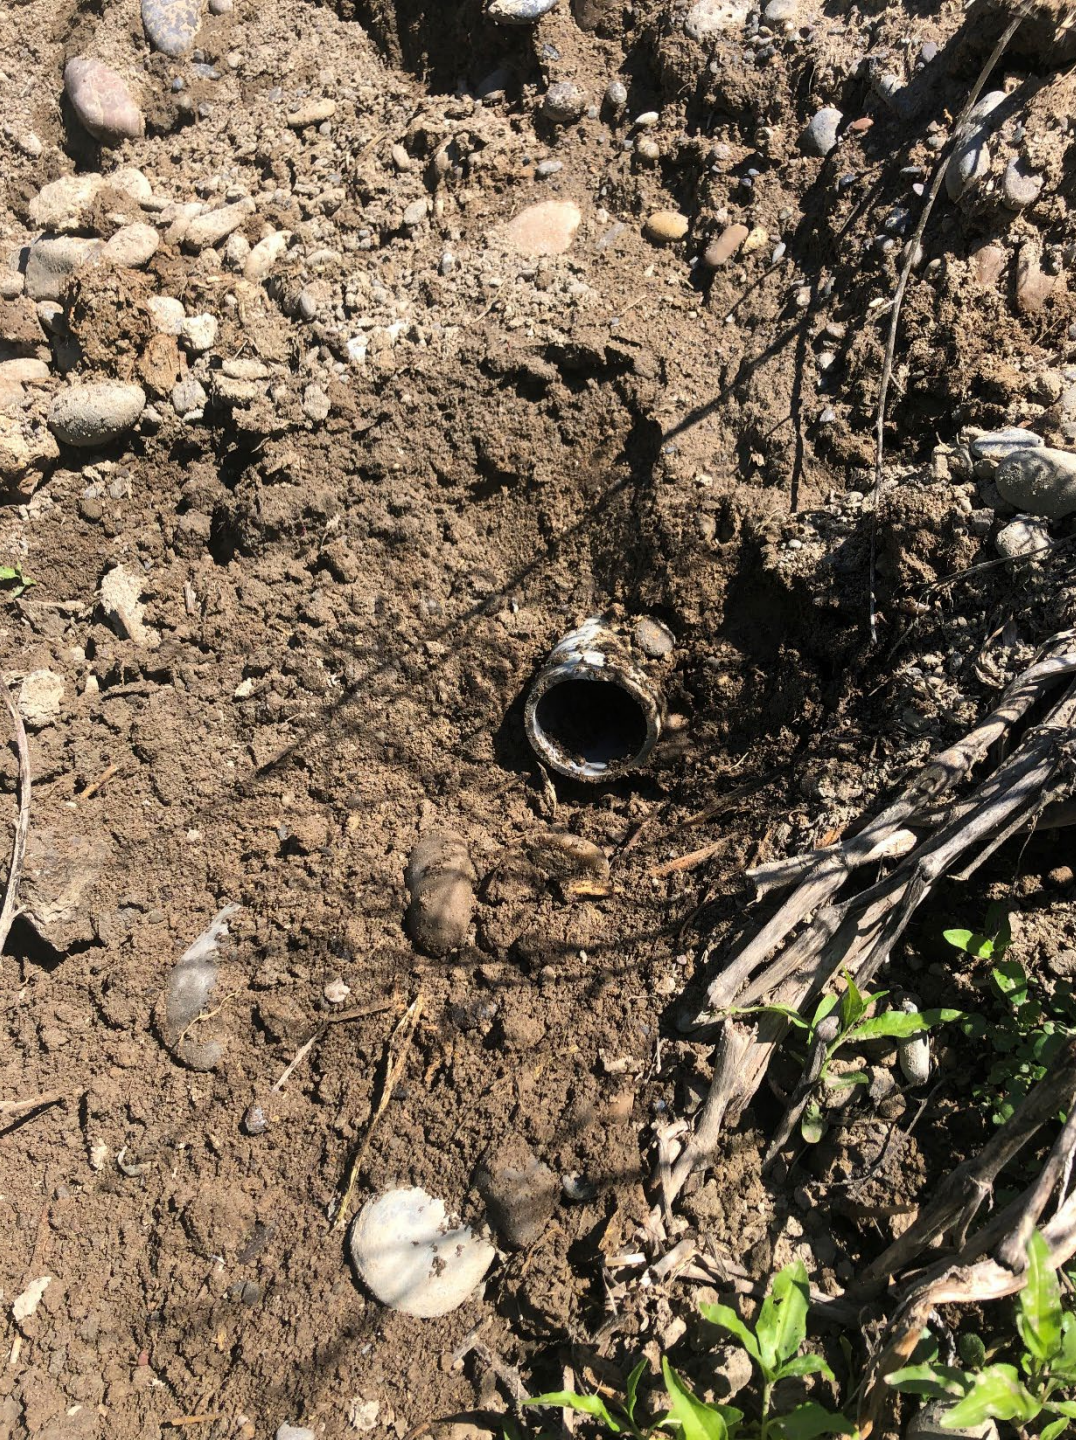
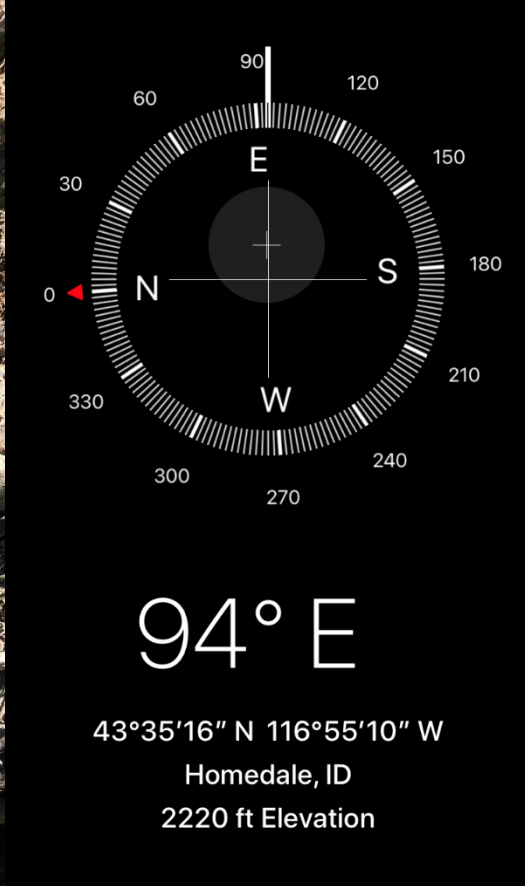
Photograph taken by Inspector Montague on May 23, 2019 facing 94 degrees East shows newly observed pipe coming from ditch bank at Owyhee Dairy. At the time of investigation no effluent was observed to be coming from pipe head.

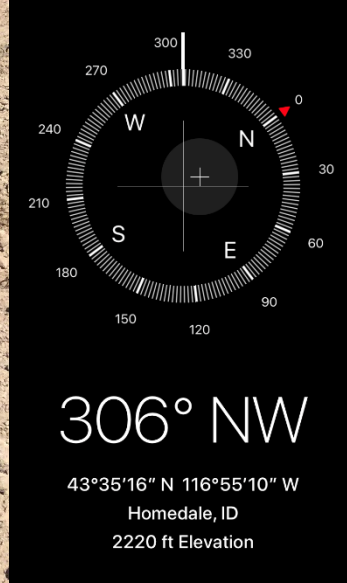
1

Effluent remnants from discharge observed on May 22, 2019.

Approximate location of where discharge was observed coming from pipe head on May 22, 2019. Pipe head was buried and not able to be seen at the time of investigation

Photographs taken by Inspector Montague on May 23, 2019 facing 306 degrees Northwest and 309 degrees Northwest shows where pipe head that was discharging on May 22, 2019 has since been covered by gravel and dirt and was not able to be inspected. Remnants of effluent remained directly below where original pipe head was observed on May 21, 2019 and May 22, 2019 at Owyhee Dairy along the ditch that borders the North and Northwest side of facility.
